Case Study Bi-directional Loadtest Bassin Austerlitz, Paris

Keywords: Case Study Bassin Austerlitz Paris, bi-directional static load test, Osterberg cell technology

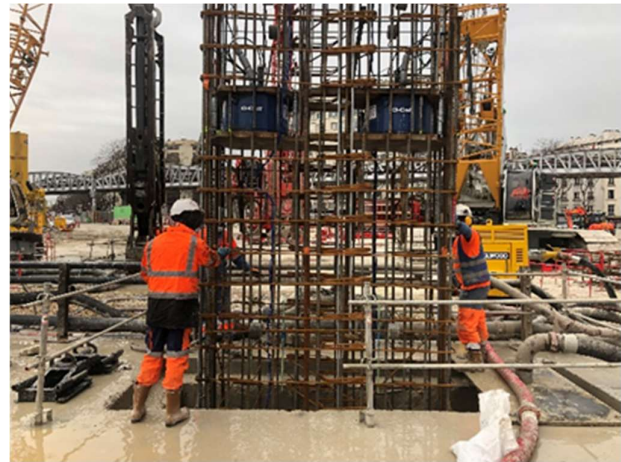
Fig. 4. Insertion of the reinforcement containing the O-cell assembly.

The testing program comprised of a single barrette test. An O-cell assembly consisting of two 690 mm diameter O-cells, capable of loading to more than 35,000 kN in each direction, was installed in the test barrette to give total gross loading capacity of 70,000 kN. Interesting to note that the Eiffel Tower is estimated to weigh 8,000 tons, more or less, so would just about provide the right top down reaction at 80,000 kN, although a little impractical to move to the test location.

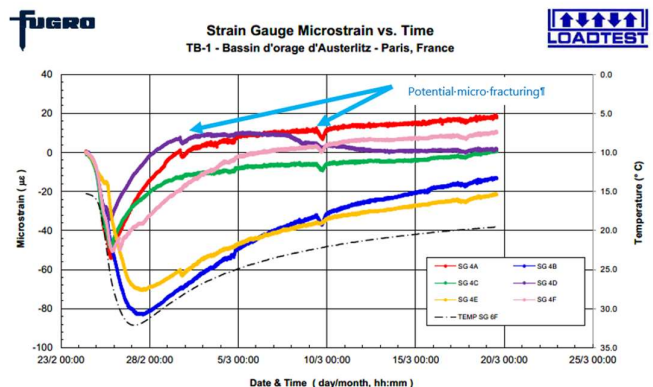
Fig. 5. Strain Gauge Microstrain v. Time with signs of potential micro fracturing.

Some evidence was found of micro-fracturing in some levels of strain gauges in the softer soil strata during curing (see also figure 5). This occurred quite some time after the concrete was poured at around 14 days, although there was some evidence of earlier potential micro-fracturing at around 7 days from casting. The changes in stress measured by the strain gauges corresponded in general, to the temperature change as the concrete cures.

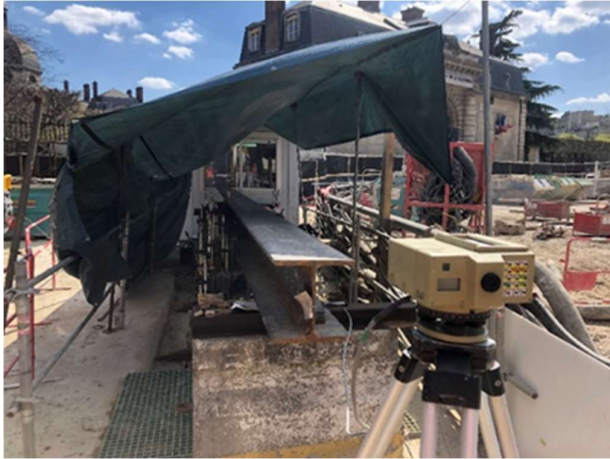
Fig. 6. Testing underway, footprint is the same as the foundation element. The beam is for datum reference only.

The testing phase was undertaken in a single cycle of loading in 18 increments to a maximum sustained load of 26.4 MN, above and below the O-cell assembly, 52.8 MN total gross loading. At this load, the displacements were sufficient for the analysis and the test was concluded. The O-cell test was performed in general accordance with the EN ISO 22477-1-E specification incorporating the recommendations published in (3). The footprint of the testing phase is the same as the foundation element. See figure 6.

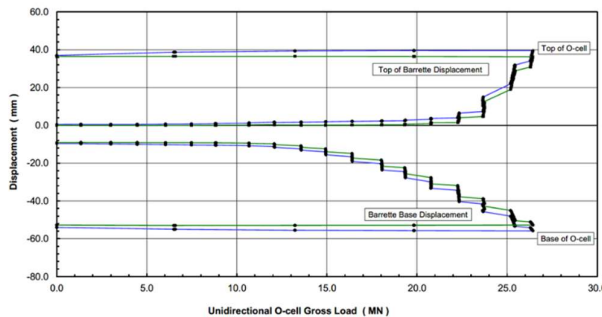
Fig. 7. Load - displacement top and base of O-cell movement.

The results of the displacements of the top and base of the barrette related to the gross load are shown in figure 7.

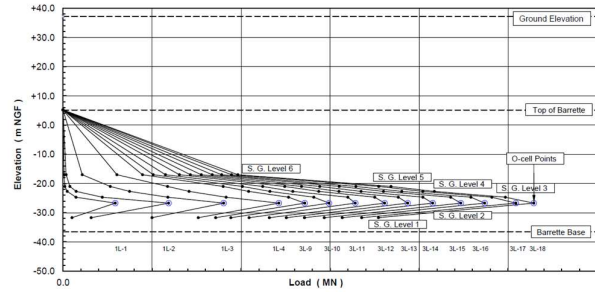
Fig. 8. Strain gauge (SG) load distribution.

The strain gauge load distribution in figure 8 illustrated that the lower marl/chalk layer was uniform in structure, with the load being generally equally distributed throughout the layer.

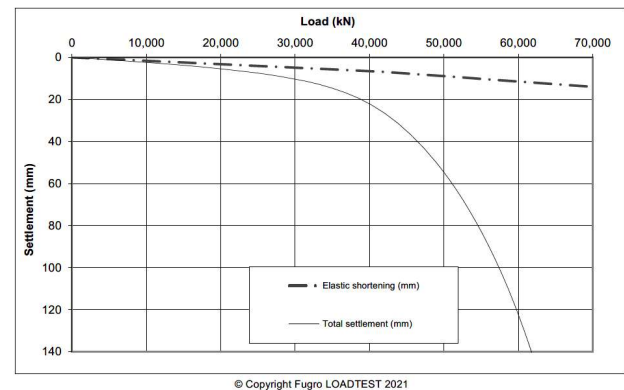
Fig. 9. Total Load-Settlement behavior.

To obtain an assessment of the full geotechnical soil parameters, a Cemsolve® analysis was made, modelling the load-displacement data upwards and downwards. These models determine the ultimate barrette skin friction and end bearing characteristics, together with an assessment of the stiffness of the soils at the barrette base. An equivalent load – movement curve using the combined results with Cemset® to assess the movements at the top of concrete elevation in compression is shown in Figure 9.
